# Deformation and Migration of Palmaz Stents after Placement in the Tracheobronchial Tree<sup>1</sup>

JVIR 1999; 10:209-215

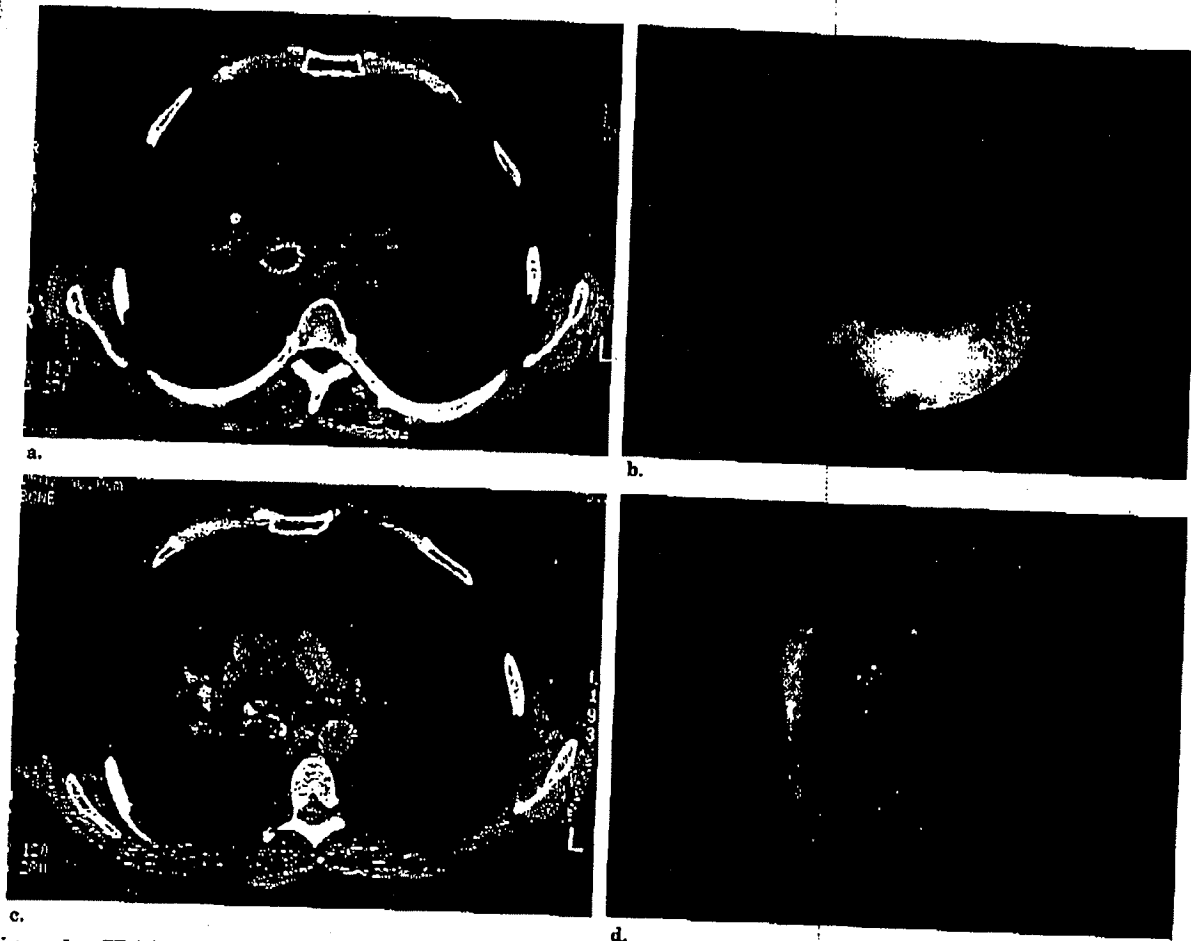
**Figure 1.** CT (a) and bronchoscopic images (b) of patient 1 44 days after placement of two Palmaz stents in the right mainstem bronchus. (a) CT image at the level of the right upper lobe bronchus demonstrates wide patency of the stented right mainstem bronchus. (b) Bronchoscopic image demonstrates superior aspect of the right mainstem bronchus Palmaz stent just distal to the carina. The stent is widely patent. CT (c) and bronchoscopic (d) images of patient 1 219 days after placement of Palmaz stents in the right mainstem bronchus. (c) CT image at the same level depicted in (a) reveals distortion and collapse of the previously placed stents. (d) Bronchoscopic image at the carina demonstrates partial occlusion of the right mainstem bronchus caused by the collapsed stents.

after the initial stent placements (Fig 1a, 1b). The examinations were performed during both inspiration and expiration. Covering of the right middle lobe orifice resulting from a 0.5-cm displacement of the previously placed bronchus intermedius stent was identified at this time. A tip-deflecting wire was used to hook and remove this stent under bronchoscopic guidance 5 days later. A new, 15-mm-long Palmaz stent (P164) was positioned in the bronchus intermedius and dilated to 12 mm. A second, 20-mm-long Palmaz stent (P204) was placed coaxially through the first to

extend the stented region. The migration of the bronchus intermedius stent was clinically occult. The patient had remained without evidence of recurrent pulmonary infection since the initial stent placements. CT of the chest was performed 219 days after the initial stent placements when the patient again presented with airway infection. Crumpling of the stents within the right mainstem bronchus was identified at this time. The failure was subsequently confirmed at bronchoscopy (Fig 1c, 1d). Removal was attempted, but unsuccessful despite

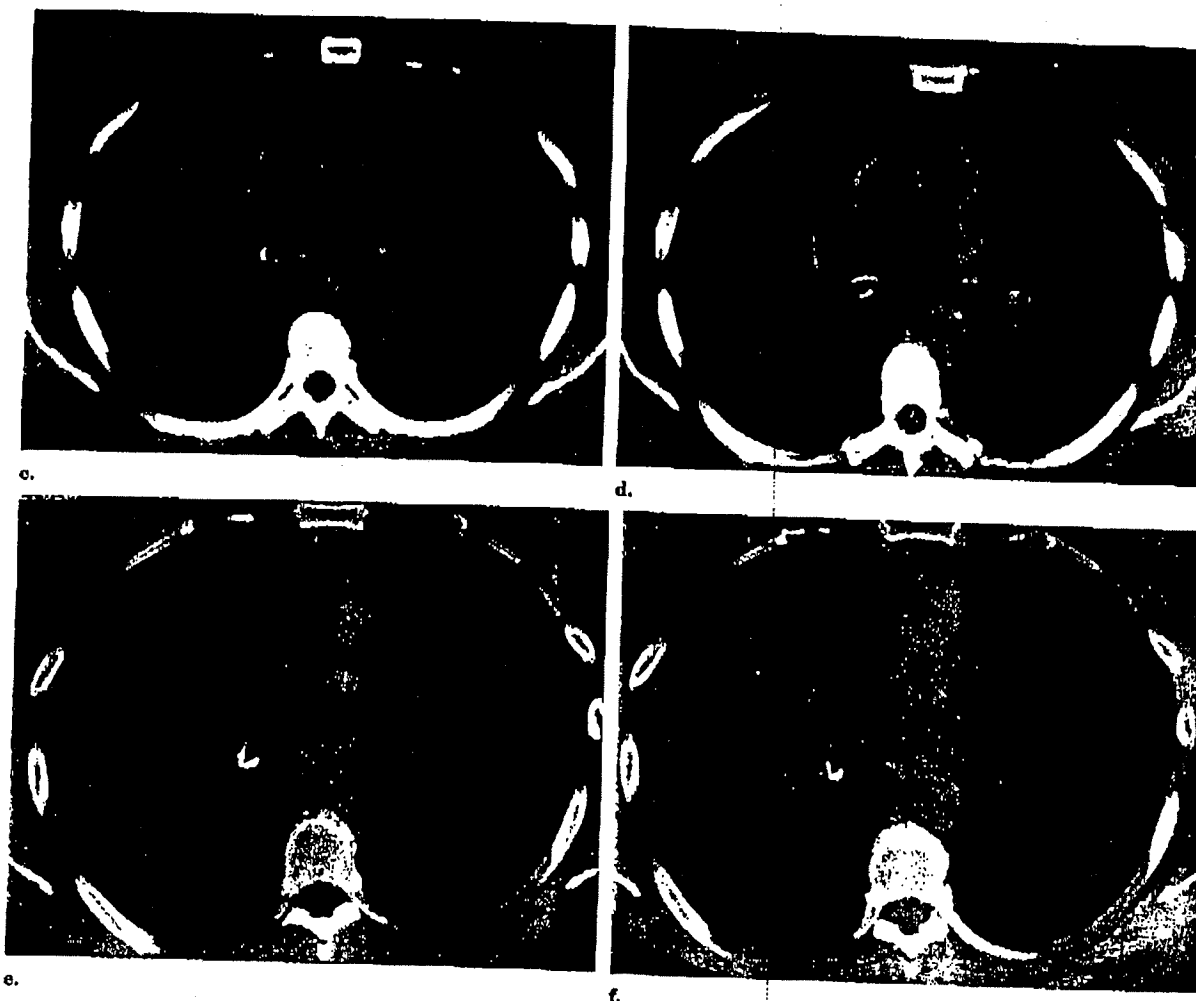
**Figure 3.** (c, d) Contiguous 7-mm CT images of the same patient 211 days after left mainstem bronchus stent placement. Interval displacement of the stent into the bronchus intermedius is evident. Despite its change in position, the stent remains patent although its lumen diameter is decreased. (e, f) Contiguous 3-mm CT images of the thorax 146 days after the examination pictured in Figure 3b. Further distal migration of the stent into the right lower lobe bronchus is seen. The Palmaz stent has become distorted and its lumen is collapsed.

In two of our patients (patients 1 and 3), stent migration was also identified. Patient 3 experienced spontaneous migration of a stent from the left mainstem bronchus into the bronchus intermedius. Although the lumen of the stent remained patent despite this translocation, a decrease in stent diameter was seen. Compression and decreased diameter of the stents with resultant loosening probably permitted these migrations to occur.
